# Snohomish County Marine Resources Program

**Prioritization of Pilings  
for Removal from the Snohomish Estuary  
Phase 1 Status Report and Planning for Phase 2**

Elisa Dawson

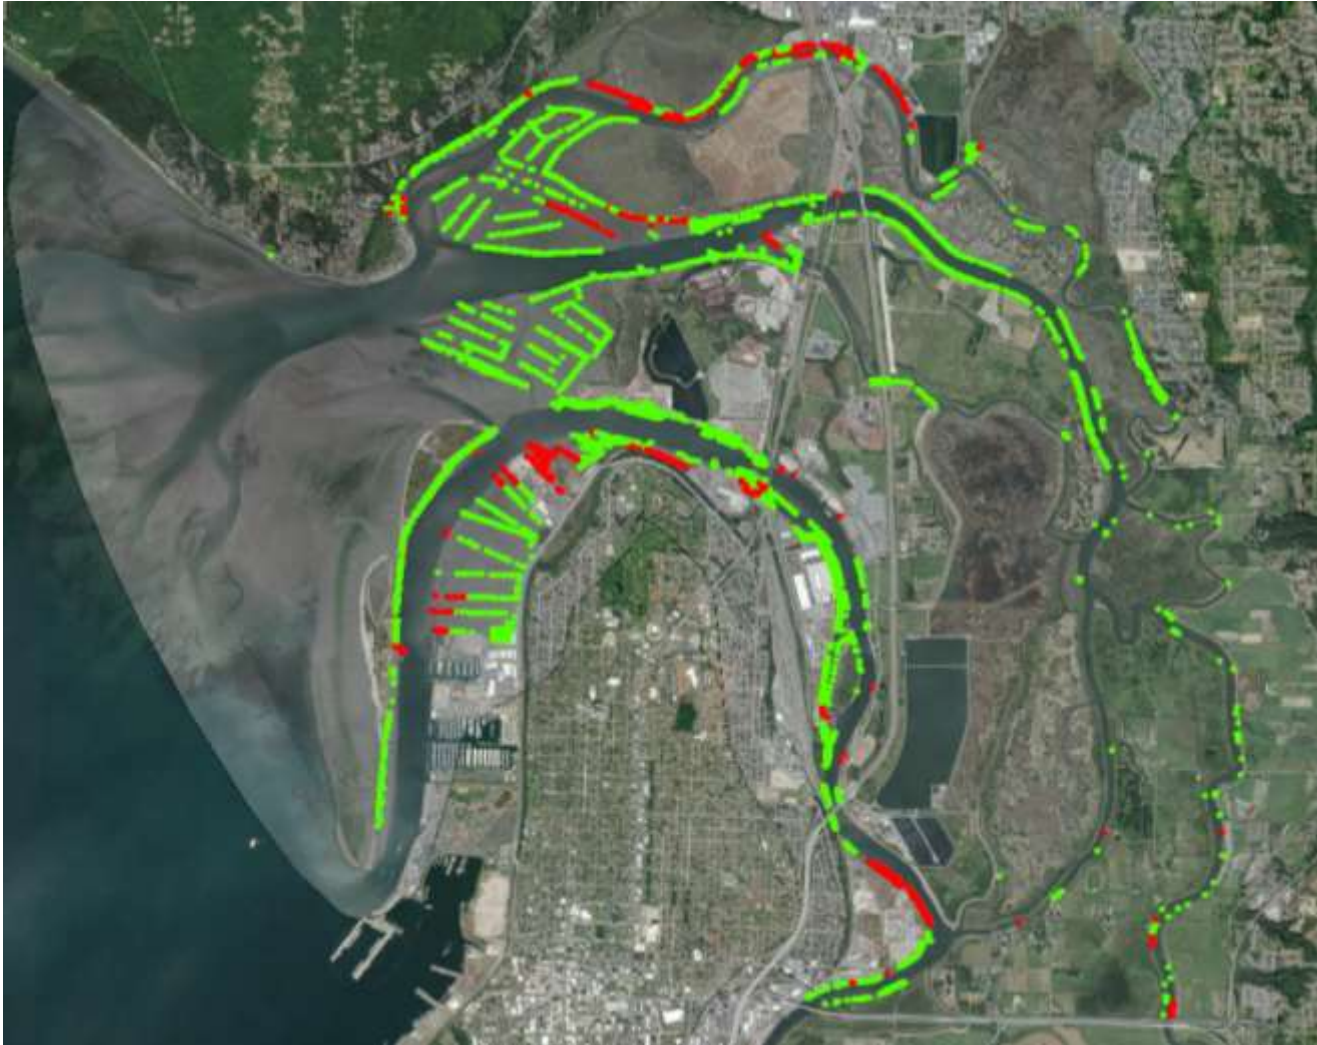
# Creosote-Treated Pilings

**Total 15,526 Pilings**

2,455 pilings or  
nearly 16% are  
creosote-treated

Red = Creosote

Green = Not  
Creosote

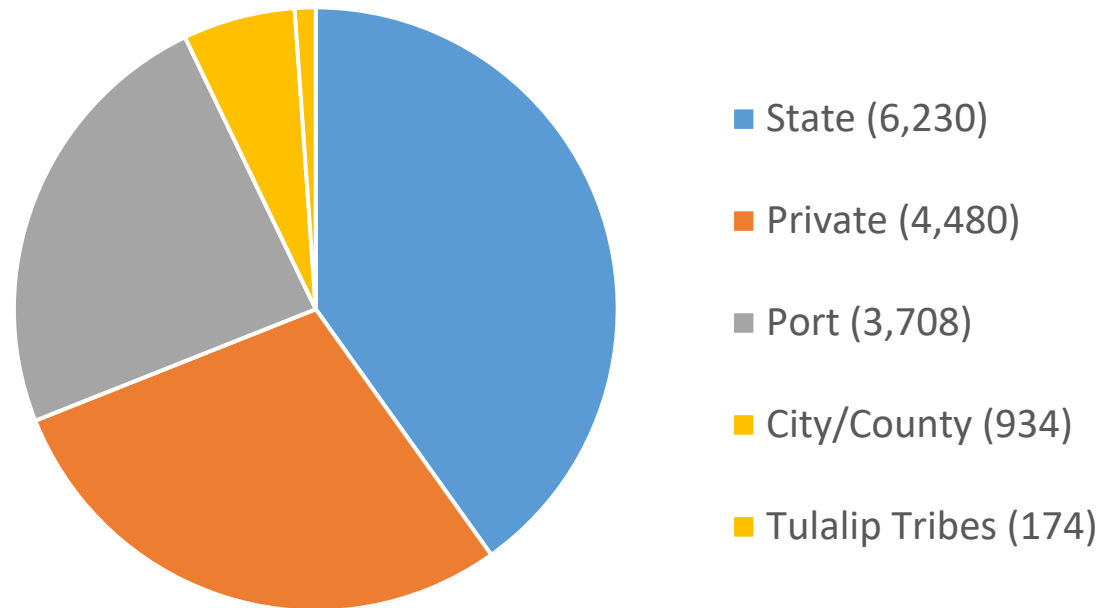
# Ownership Overview

Ownership by Count

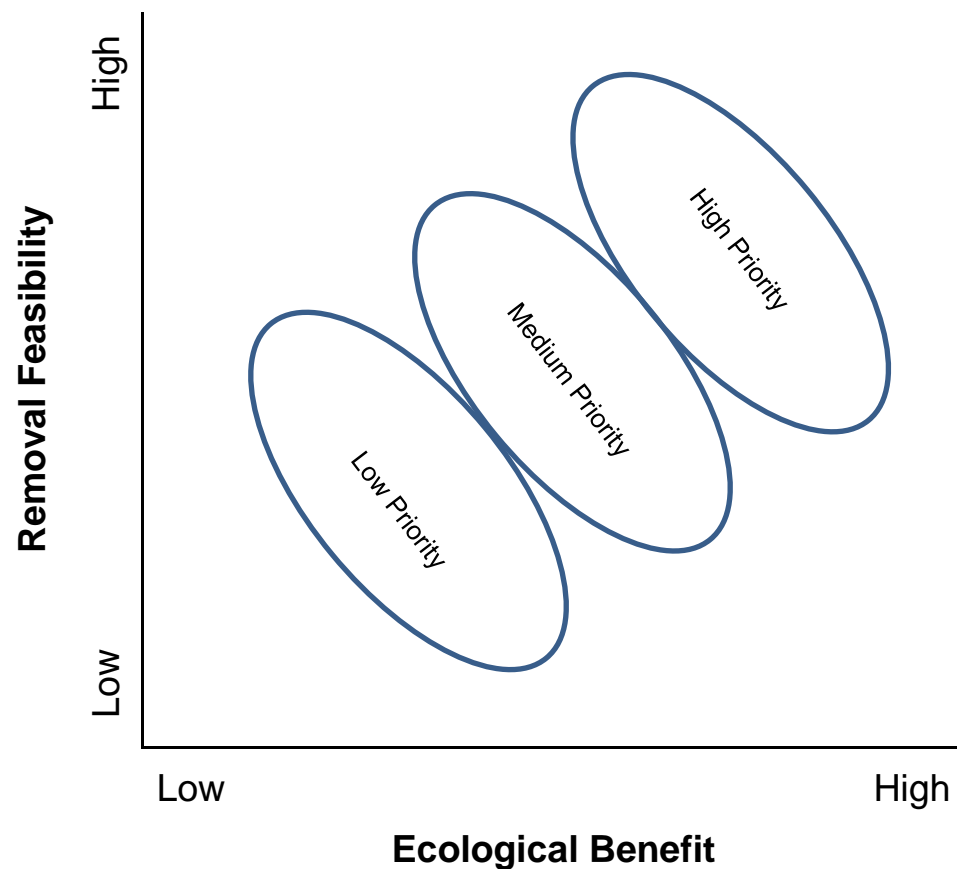
# Conceptual Depiction of Two-Axis Prioritization Approach

Rather than one collective score, decided to separately characterize for each piling the ecological benefits of removal and the feasibility of removal

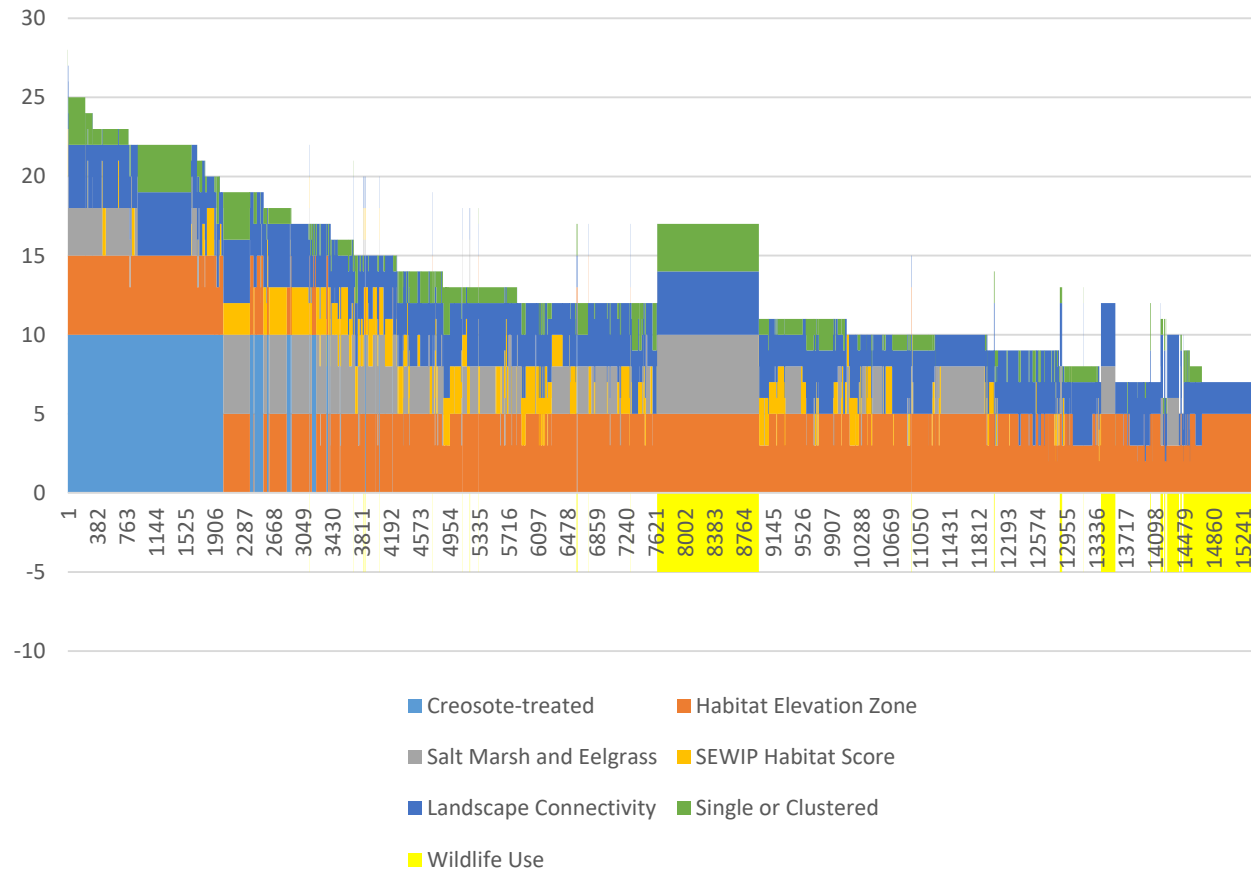
# Prioritization Results – Ecological Benefits

Benefit Score by Parameter

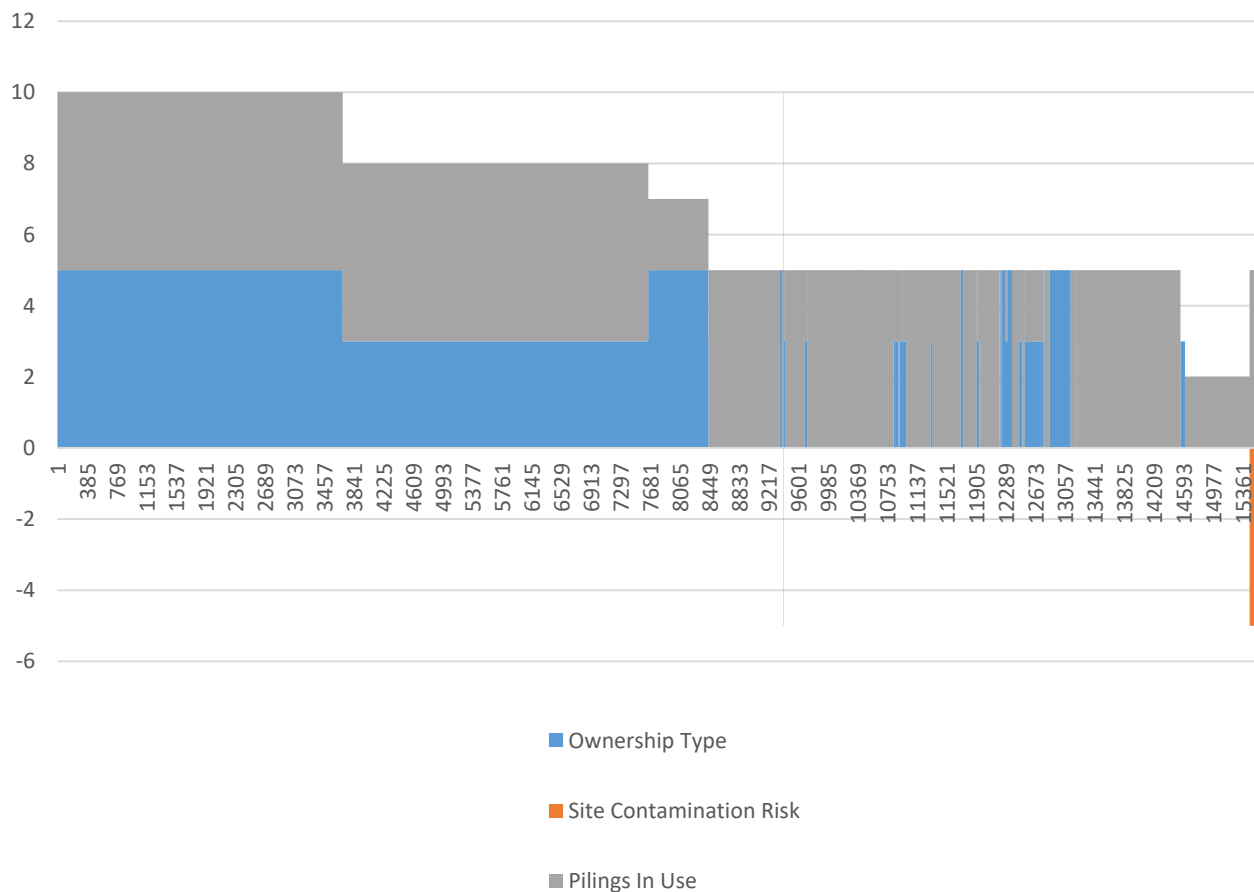
# Prioritization Results – Feasibility

Feasibility Score by Parameter

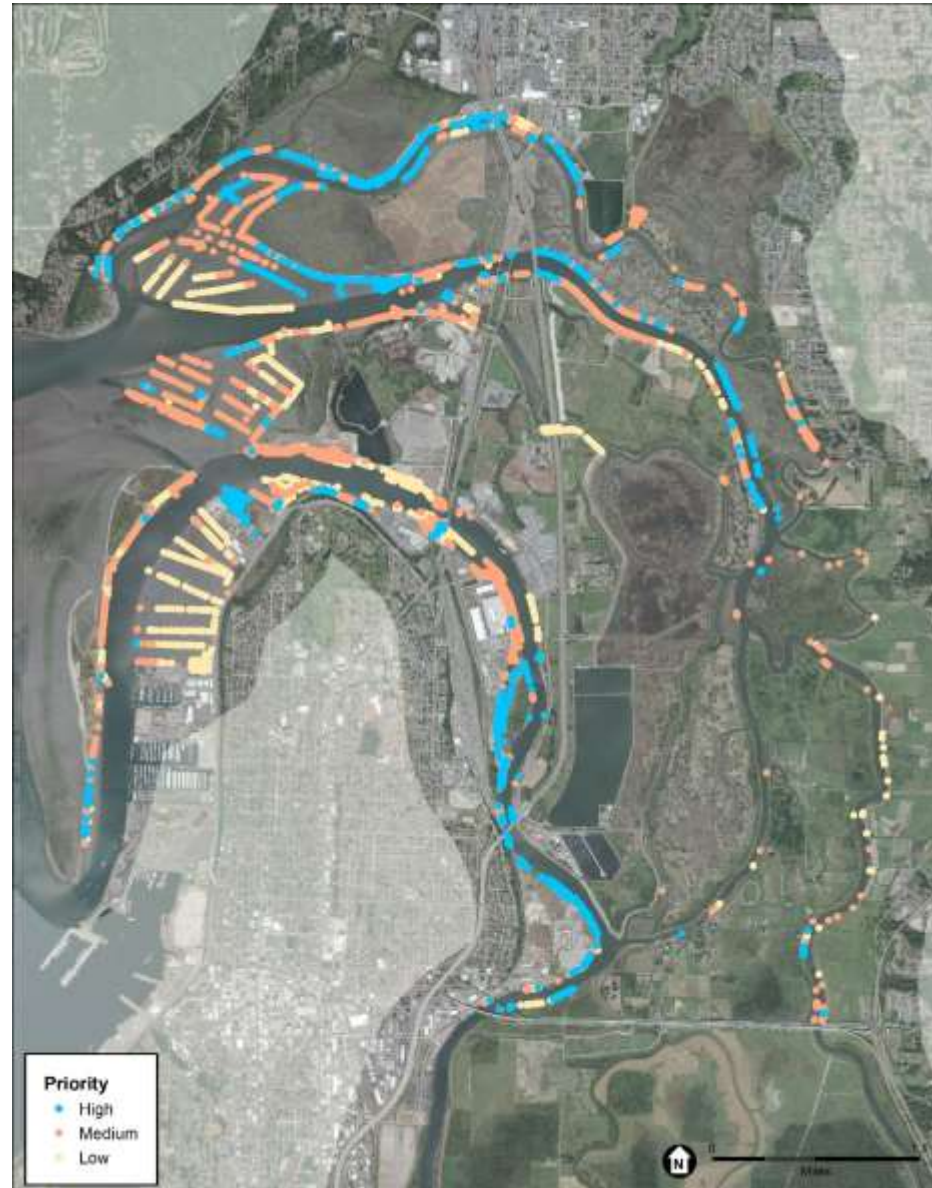
# Priority Ranking of Pilings

Blue = High

Orange = Medium

Yellow = Low

26% High

38% Medium

36% Low

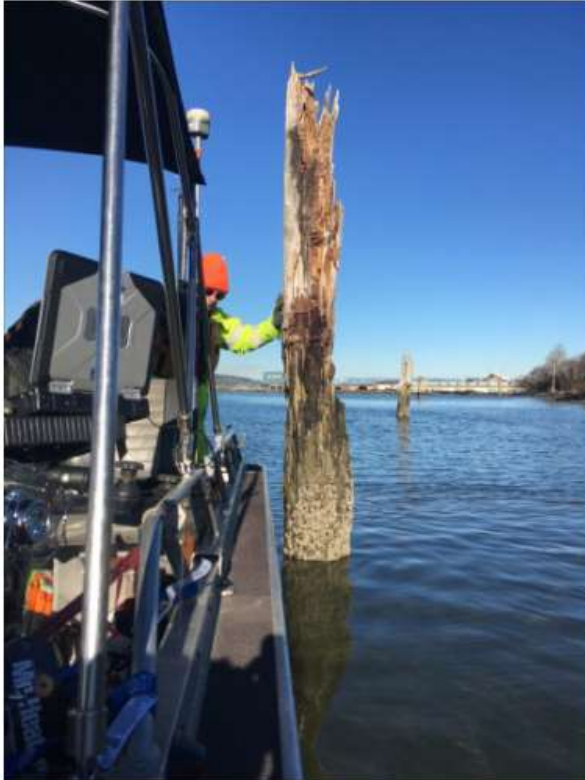
## Creosote Piling Report by **Elisa Dawson**

Recorded From: On the water directly next to the piling

Piling Diameter (approximated): 18 inches

Piling Height Above Water (approximated): 6ft

Number of pilings: 1

Piling in use: No
